NPIC/R-93/64  
February 1964

PHOTOGRAPHIC INTERPRETATION REPORT

MAJOR COMPLEX UNDER  
HIGH-PRIORITY CONSTRUCTION  
NEAR HSING-LUNG-CHUANG, CHINA

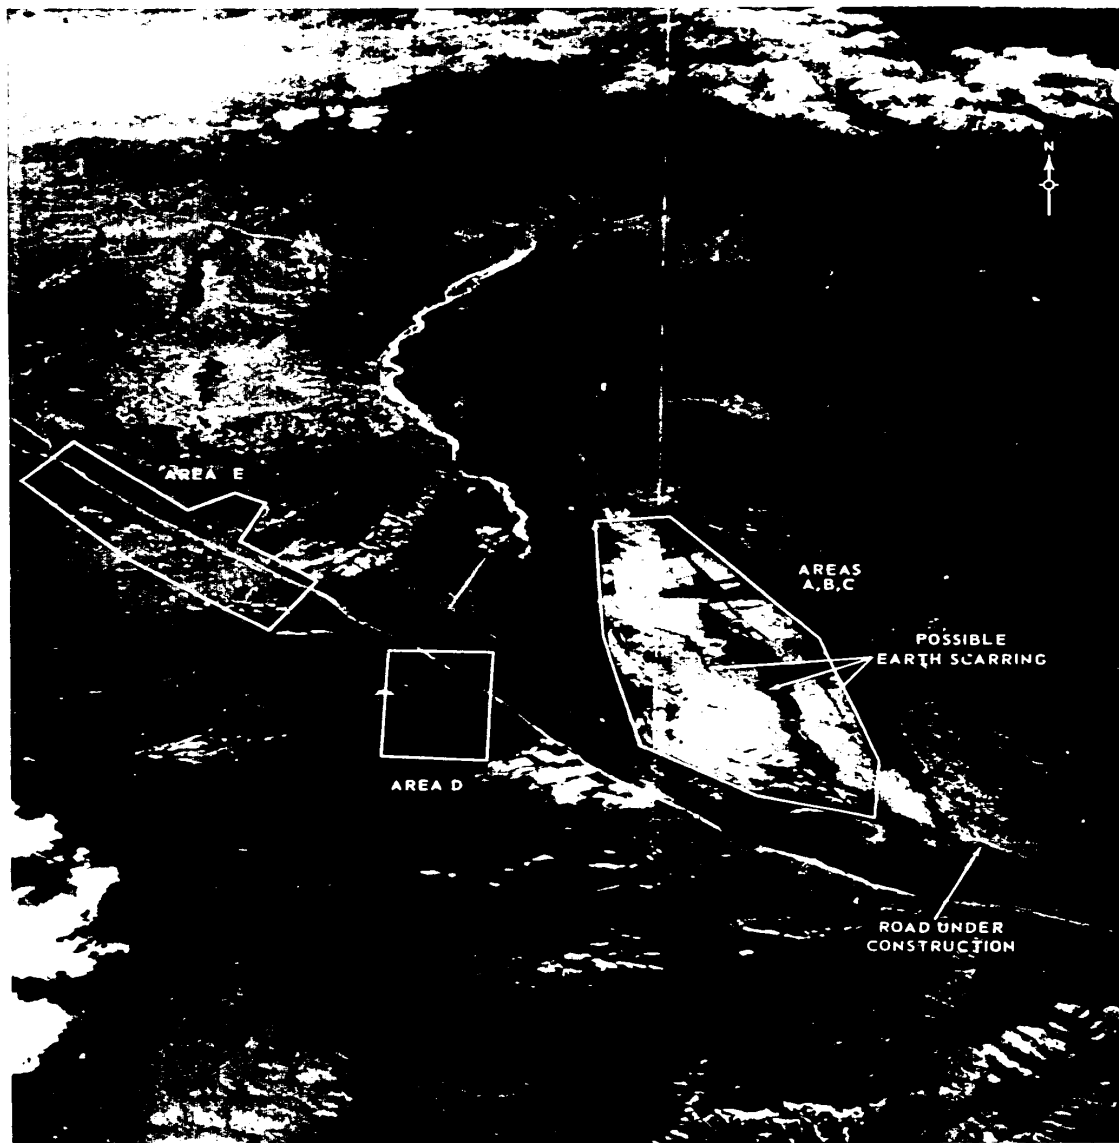
FIGURE 2. Hsing-Lung-Chuang AREA, SEPTEMBER 1959.

The site was first seen on far-oblique photography of September 1959 (TALENT Mission [redacted]). At that time agricultural field patterns covered the area, and a road under construction into the area could be observed (Figure 2). Light toned areas of possible earth scarring seen on this photography may represent initial construction efforts at this installation. Photography of September 1961 (KEYHOLE Mission [redacted]) was the first to reveal the installation under construction, and a photographic interpretation re-

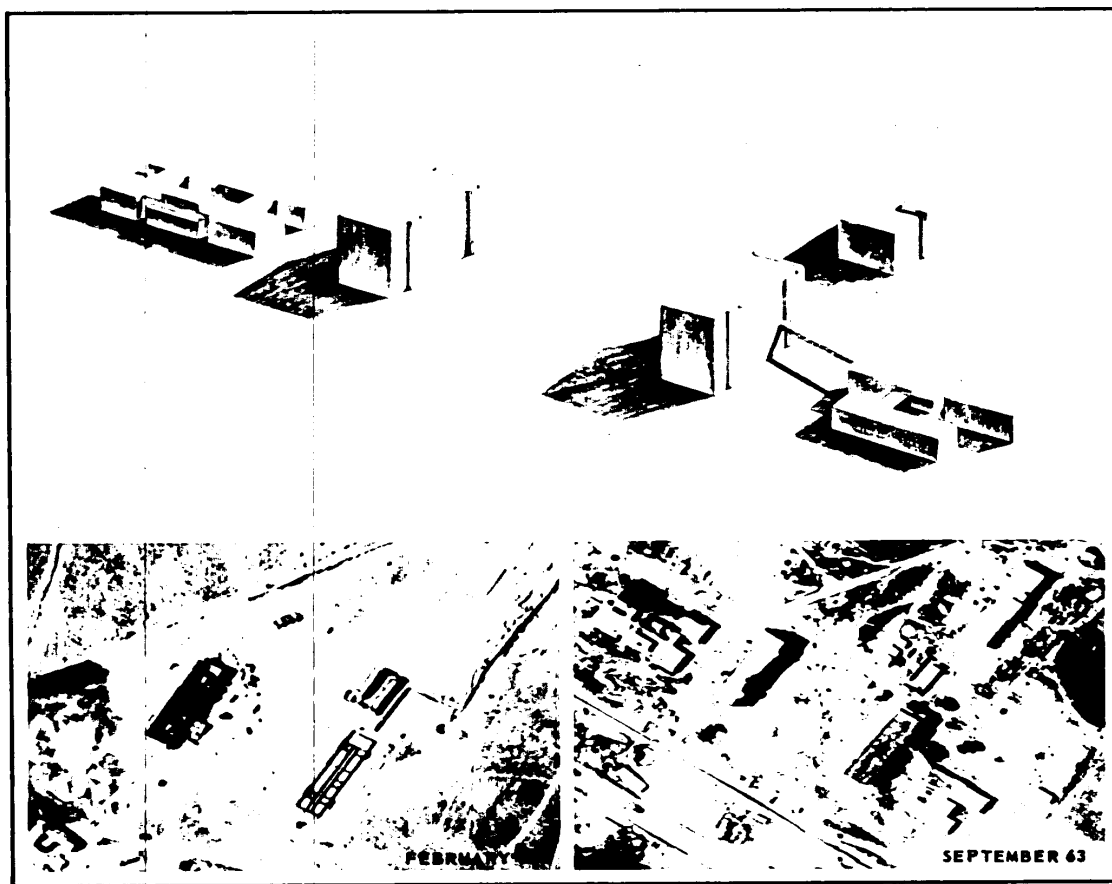
FIGURE 14. LABORATORY INSTITUTIONAL BUILDINGS, AREA B.

one of the buildings were under construction. The layout of all three appeared to consist of a center hall flanked by rooms of various sizes (inset, Figure 14). At that time work had not yet started on the two irregularly shaped structures. Photography of September 1963 (inset, Figure 14) revealed that all five structures were nearing completion with a considerable amount of construction debris remaining in the vicinity.

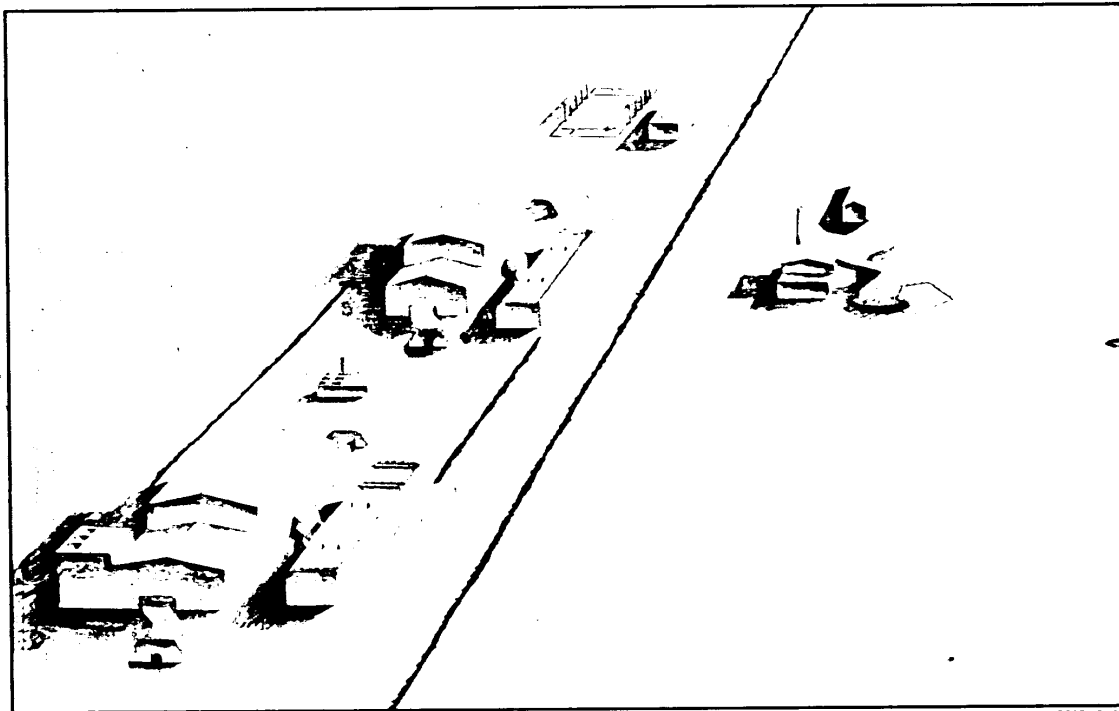
FIGURE 18. PROCESSING BUILDINGS, AREA C (perspective drawing based on February 1962 photography).

the associated buildings had been increased to such a height that their shadows obscured the processing buildings and also because the processing buildings may have been partially covered with earth.

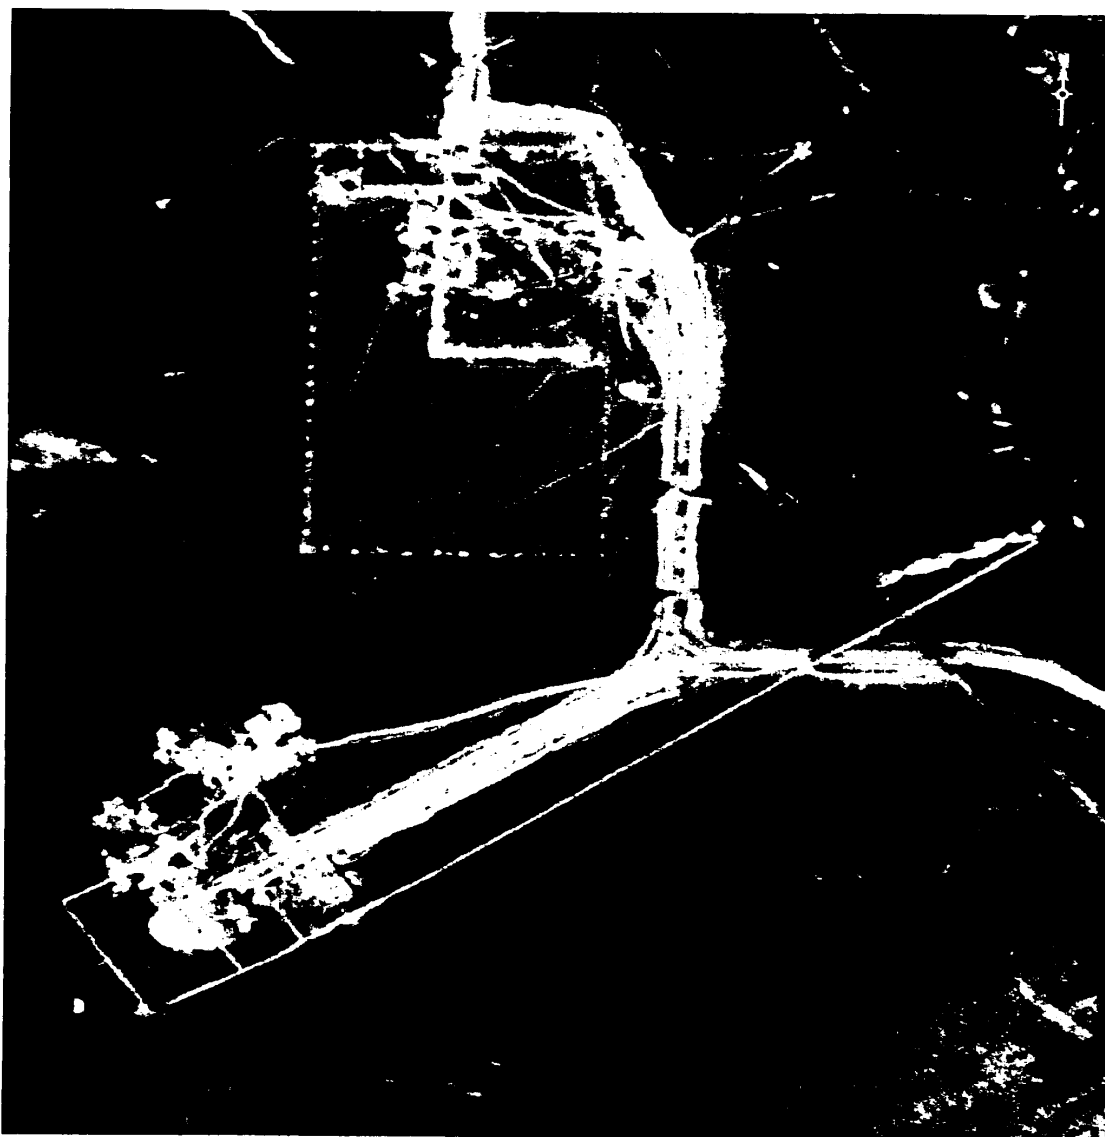
FIGURE 19. AREA D, AUGUST 1963.

ure 19). The latest previous photographic coverage had been in December 1962, but no activity was observed in Area D at that time. Therefore, construction observed on photography of August 1963 had been developed during a period of less than eight months. A small portion of the southern segment of Area D was cloud free on the larger scale [ ] photography of September 1963, and details of construction seen on this photography permit an evaluation of the magnitude of the construction effort being expended in Area D (Figures 21 and 22).

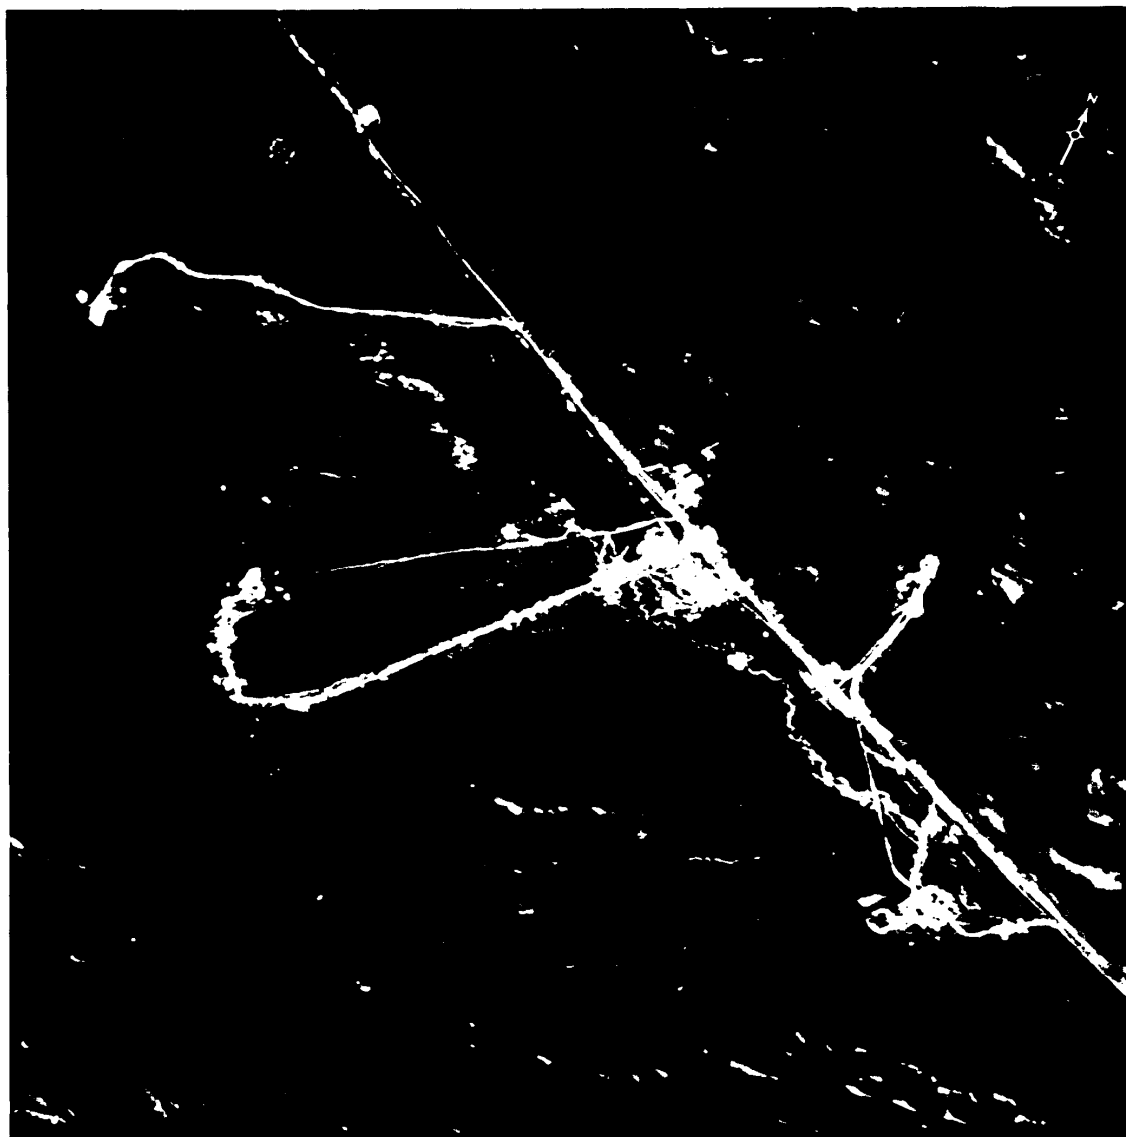
FIGURE 23. AREA E, AUGUST 1963.

A second road under construction leading northwest from the site will provide additional access to the storage sites; it connects directly with the road leading to Storage Site 1 (Figures 23 and 24).

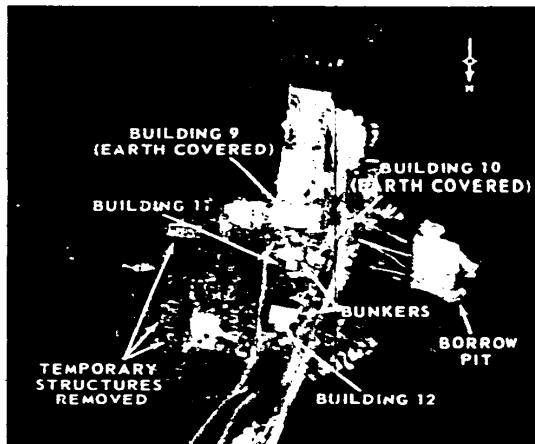
FIGURE 29. STORAGE SITE 3 OF AREA E, SEPTEMBER 1963.

In addition to the large earth-covered structure (item 9), three other structures are visible

at Storage Site 3. Two of these are square, flat-roofed buildings (items 11 and 12), each with an adjacent protecting bunker. The third building (item 10) appears on the latest photography to be earth covered. Two of the three buildings were present in February 1962 (items 10 and 11, Figure 29); the third building (item 12) and the two bunkers were added since that time. Also present in February 1962 but since removed were numerous construction shacks and tents.
